**EFFECTIVENESS OF SPEED MINDERS IN REDUCING DRIVING
SPEEDS ON RURAL HIGHWAYS IN PENNSYLVANIA**

**PennDOT/MAUTC Partnership
Research Agreement No. 510401**

FINAL REPORT

By E. T. Donnell and I. Cruzado

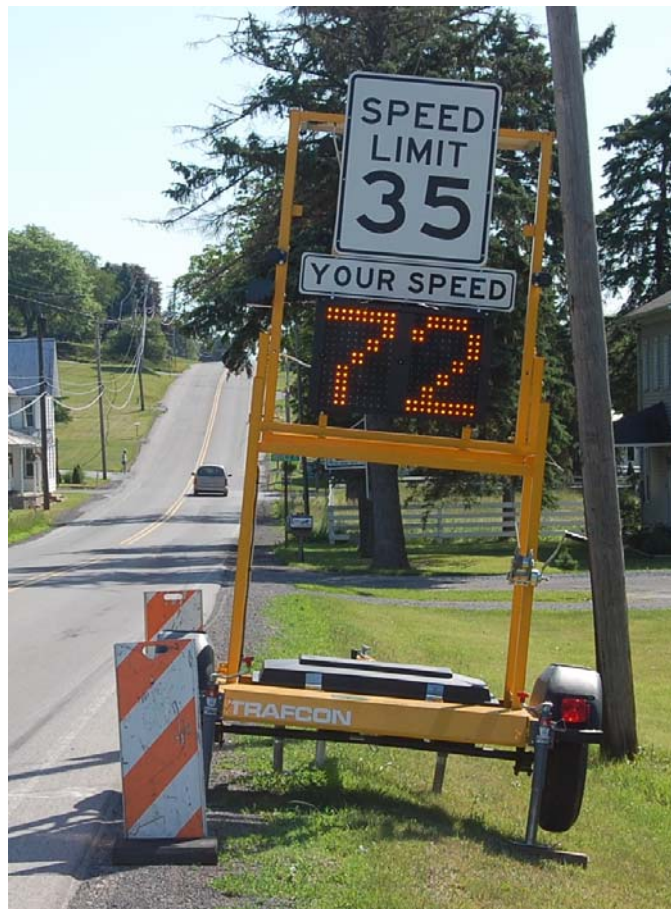
Dynamic speed display signs (also known as "speed minders") measure the speed of approaching vehicles and communicate the speed to drivers on a digital display. An example of a dynamic speed display sign is shown in Figure 1. When coupled with a posted speed limit sign, the real-time display permits drivers to compare their operating speed to the regulatory speed.

Figure 1. Dynamic Speed Display Sign.

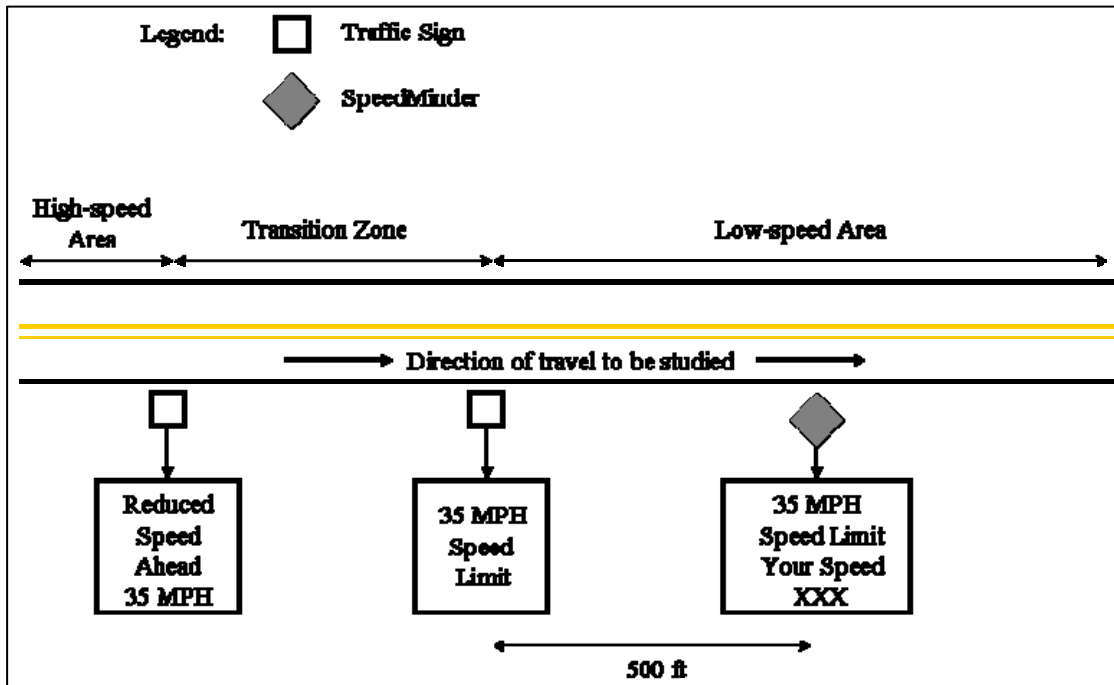
Figure 3. Speed Minder Location at a Typical Transition Zone.

Staff from PennDOT’s Engineering District 2-0 and 10-0 traffic engineering units was responsible for determining the location of the speed minders at each study site. Each speed minder location was designated prior to beginning field data collection efforts at that particular site. Of particular interest were the transition zone locations. Enforcement cannot occur within the area 500 ft downstream of a static sign that is intended to regulate a speed limit that differs from an adjacent, upstream speed zone. At each of the transition zone locations noted in Table 4, the speed minder was located at least 500 ft downstream of the speed limit sign used to designate the lower speed when compared to the adjacent speed zone. This criterion applies to sites 1 through 7, 10, 12, 13, 15, 16, and 17 in Table 4. Figure 3 shows a typical transition zone along a rural two-lane highway and the proposed speed minder location. PennDOT was responsible for informing all municipalities of the proposed speed minder locations. Additionally, PennDOT was responsible for notifying state and local enforcement personnel of the proposed speed minder locations and data collection time periods. No speed enforcement was in place at the data collection locations during the before, during, or after data collection periods.

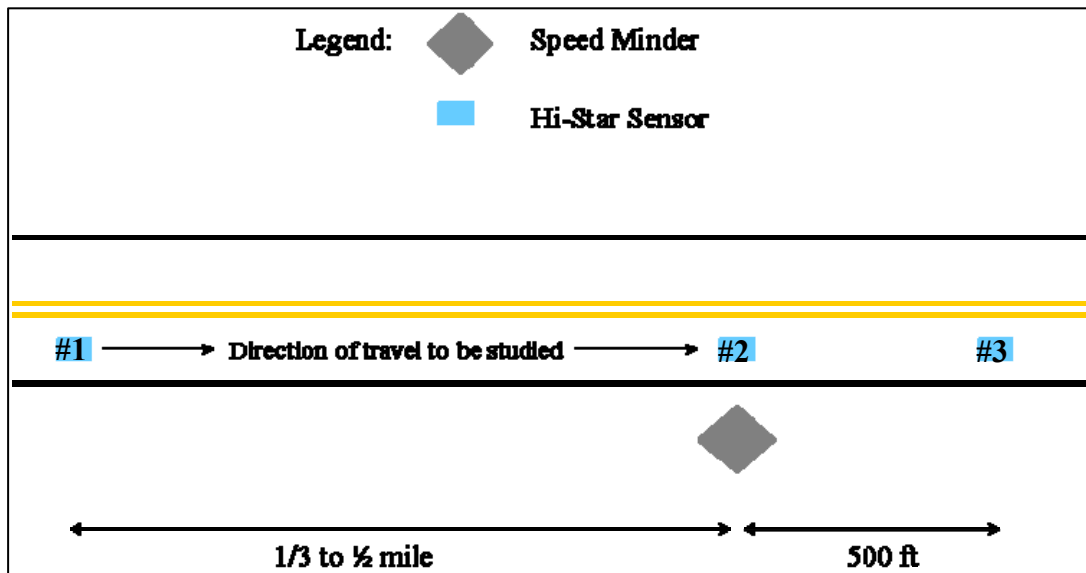
To evaluate the effectiveness of the speed minders, speed data were collected by placing the Hi-Star sensors at three different points at each study site. These locations are as follows: sensor #1, between 0.33 and 0.5 miles upstream of the speed minder location, where operating speeds can be measured without influence by the speed minder (i.e., speed minder is not visible to drivers); sensor #2, next to the speed minder, in order to record any immediate speed reductions due to implementation of the device; and sensor #3, 500 ft downstream of the speed minder implementation location, to record any additional speed reductions attributable to the presence of the device. Figure 4 shows the location of the Hi-Star sensors along a study site in relation to the speed minder location.

Figure 4. Location of Hi-Star Sensors Relative to Speed Minder Location.

Speed data were collected using Nu-Metrics Hi-Star sensors. The Hi-Star sensors use vehicle magnetic imaging technology to record vehicle count, speed, headway, time, pavement temperature, pavement condition (dry or wet), and vehicle length. These sensors are non-intrusive, thus eliminating the possibility of vehicles adjusting their speeds due to visible equipment and human observers. The dimensions of the sensor are 6.5 inches by 5.5 inches with a thickness of 0.625 inches. The sensor is placed in the center of the travel lane and when a vehicle passes over it, changes in the magnetic field are captured by the sensor. A rubber cover is used to protect the sensor and at the same time reduce its conspicuity; this cover blends in with the pavement, thus minimizing visibility. The Highway Data Management (HDM) software was used to download the data from the sensors into Microsoft Excel spreadsheets for efficient data management.

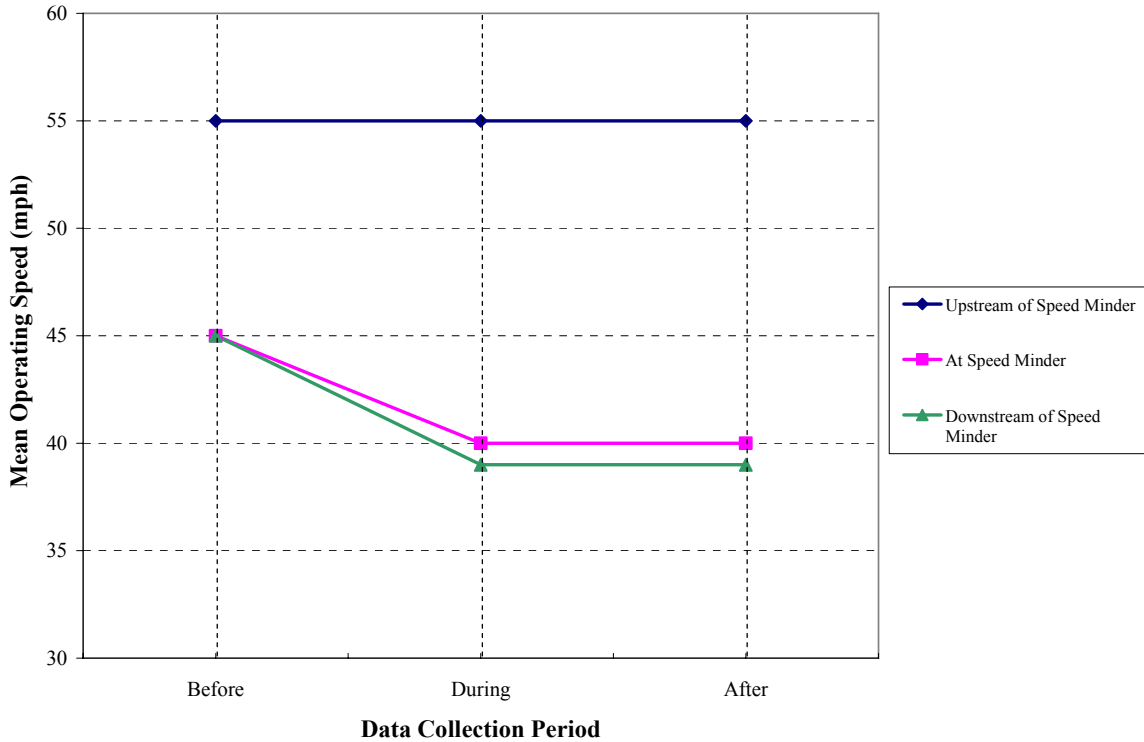
Figure 5. Anticipated Speed Profile at Sites with Speed Limit Reduction (Transition Zones).

As shown in Figure 5, the mean speed is constant at the upstream data collection point (sensor #1) in the before, during, and after periods. At the speed minder data collection point (sensor #2), the mean speed is lower in the before period when compared to the upstream data collection point (sensor #1). The mean speed at the speed minder data collection point in the during period is lower than the mean speed in the before period – this indicates that the speed minder did affect (i.e., decrease) mean operating speeds. The mean operating speed at the speed minder data collection point is the same in the after period as in the during period, indicating that the speed reduction effects observed when the speed minder was in place remained constant after the speed minder was removed from the site. The mean speed at the downstream data collection point (sensor #3) is intended to be similar to the speed minder location (sensor #2), indicating that the speed reduction observed at this location during and after speed minder implementation was the same as at the speed minder data collection point.

None of the study site locations where a posted speed limit change was present exhibited the ideal or anticipated results; however, several sites exhibited many of the characteristics associated with the ideal scenario shown in Figure 5. The primary reason that the ideal scenario was not completely observed was because after the speed minders were removed from the site, the mean operating speeds increased to a level that was nearly identical to the before period mean operating speeds. Several interesting findings are of note:

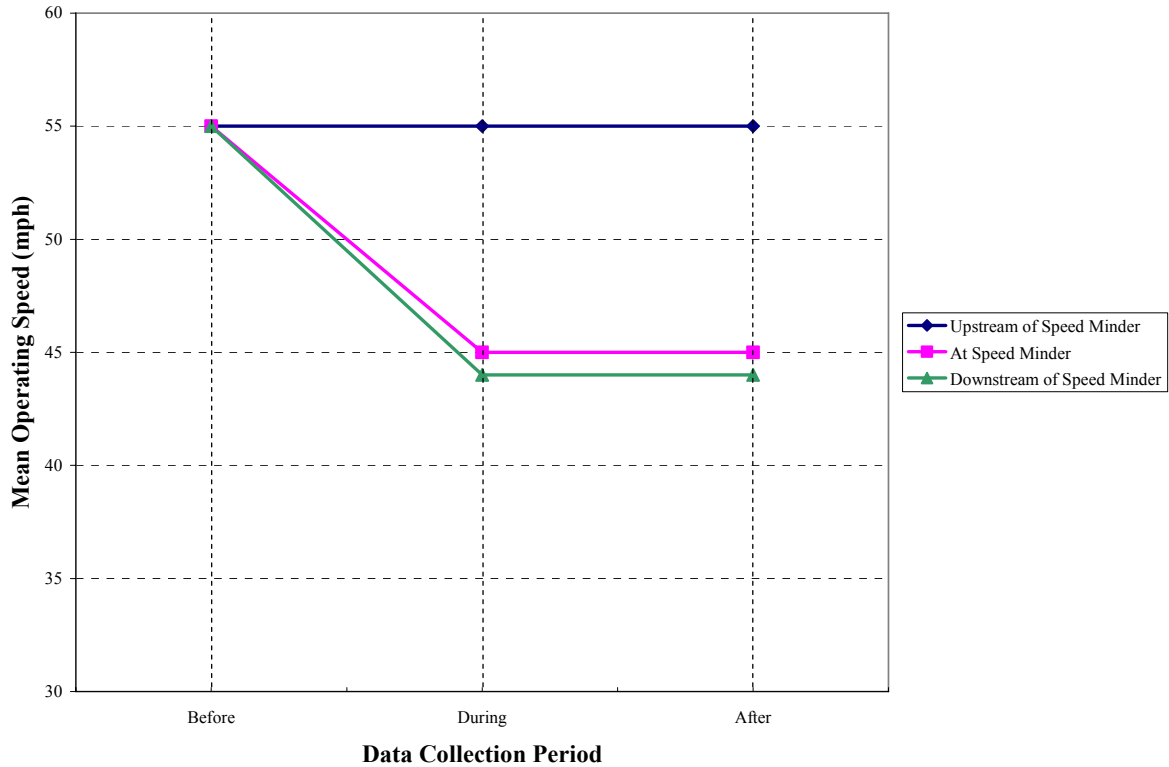
Figure 6. Anticipated Speed Profile at Sites with No Speed Limit Change.

As shown in Figure 6, the mean speed is constant at the upstream data collection point (sensor #1) in the before, during, and after periods. At the speed minder data collection point (sensor #2), the mean speed is equal in the before period when compared to the upstream data collection point (sensor #1) because no posted speed limit change occurs at the site. The mean speed at the speed minder data collection point in the during period is lower than the mean speed in the before period – this indicates that the speed minder did effect (i.e., decrease) mean operating speeds. The mean operating speed at the speed minder data collection point is the same in the after period as in the during period, indicating that the speed reduction effects observed when the speed minder was in place remained constant after the speed minder was removed from the site. The mean speed at the downstream data collection point (sensor #3) is intended to be similar to the speed minder location (sensor #2), indicating that the speed observed at this location before, during, and after speed minder implementation was the same as at the speed minder data collection point.

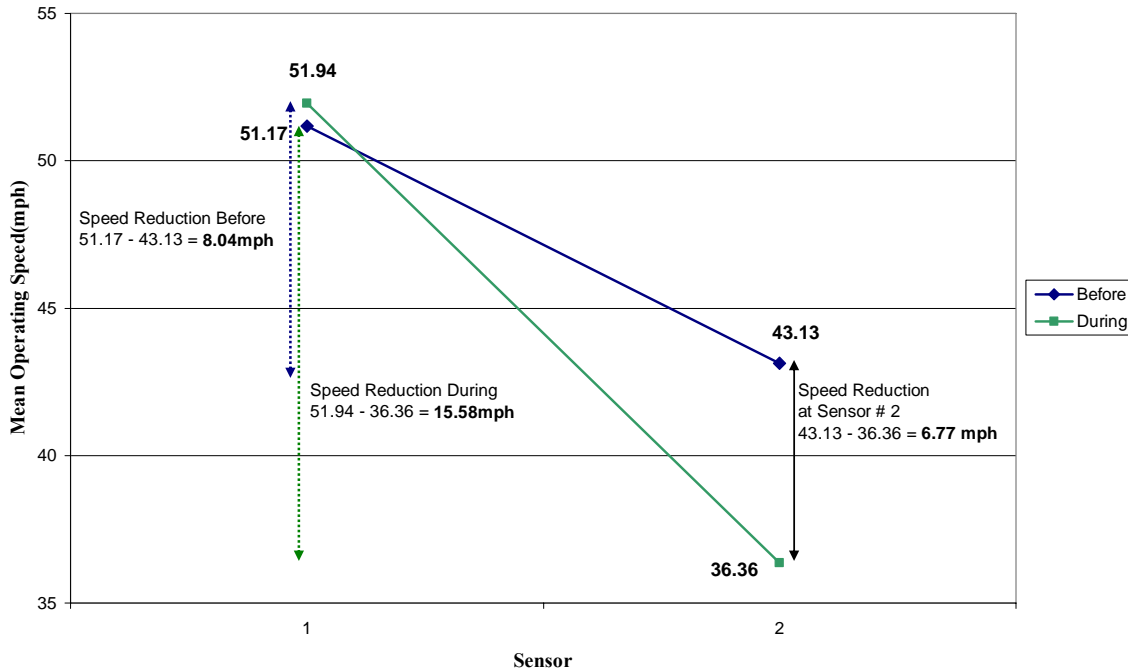
Sensor	Period		Difference Before – During
	Before	During	
1	51.17	51.94	-
2	43.13	36.36	6.77
Difference Sensor 1 – Sensor 2	8.04	15.58	T.E. = 7.54

Figure 7. Speed Differential Example to Determine True Effect of Speed Minder.

- Because Route 322 is a transition zone, a speed reduction between sensors #1 and #2 was expected. In the “before” period, the mean speed reduction was 8.04 mph (51.17 – 43.13). In the “during” period, the mean speed reduction was 15.58 mph (51.94 – 36.36). The difference between these (7.54 mph) is the true representation of the speed minder effectiveness. As noted earlier, the methods used in section 5.1 showed that the speed reduction at the speed minder point (sensor #2) was 6.77 mph, which was an underestimation of the “true effect” using tracked vehicles and speed differential data.

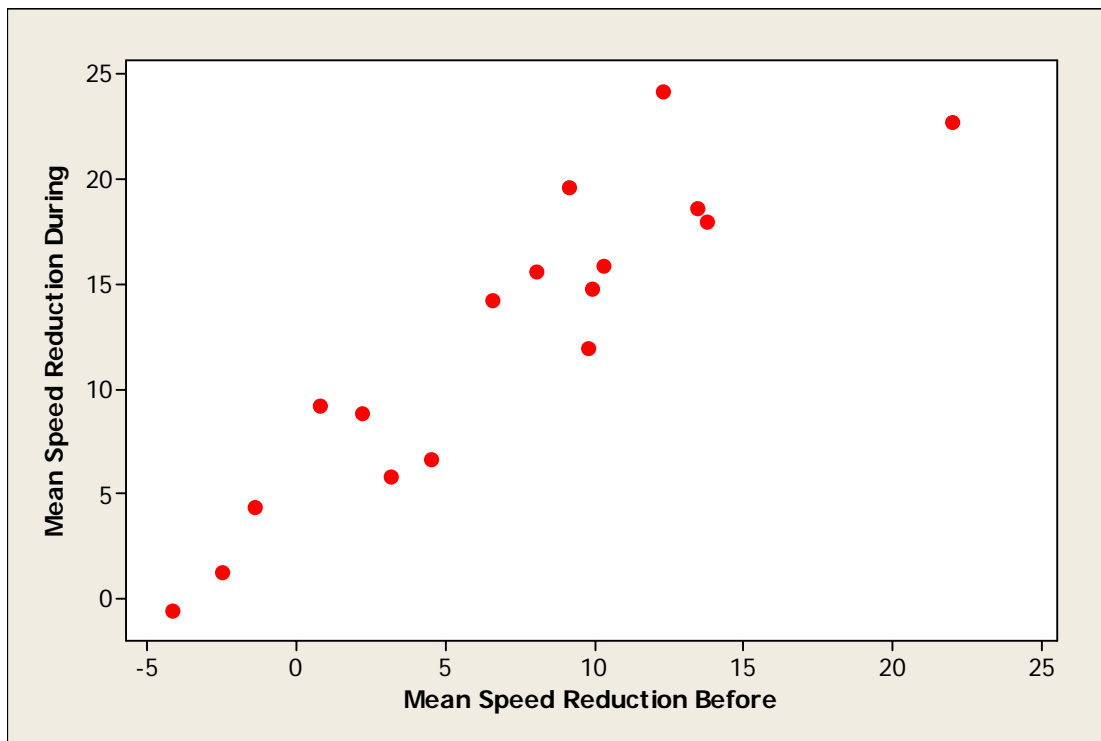
For each site, the mean speed reduction for the before and during periods were plotted on separate axes as shown in Figure 8. The plot shown in Figure 8 indicates a positive linear relationship between the two speed reduction variables.

Figure 8. Plot of Mean Speed Reductions in Before and During Periods.

A linear regression model was specified to determine if the mean speed reduction in the during period is correlated with the mean speed reduction in the before period. The regression equation developed was as follows:

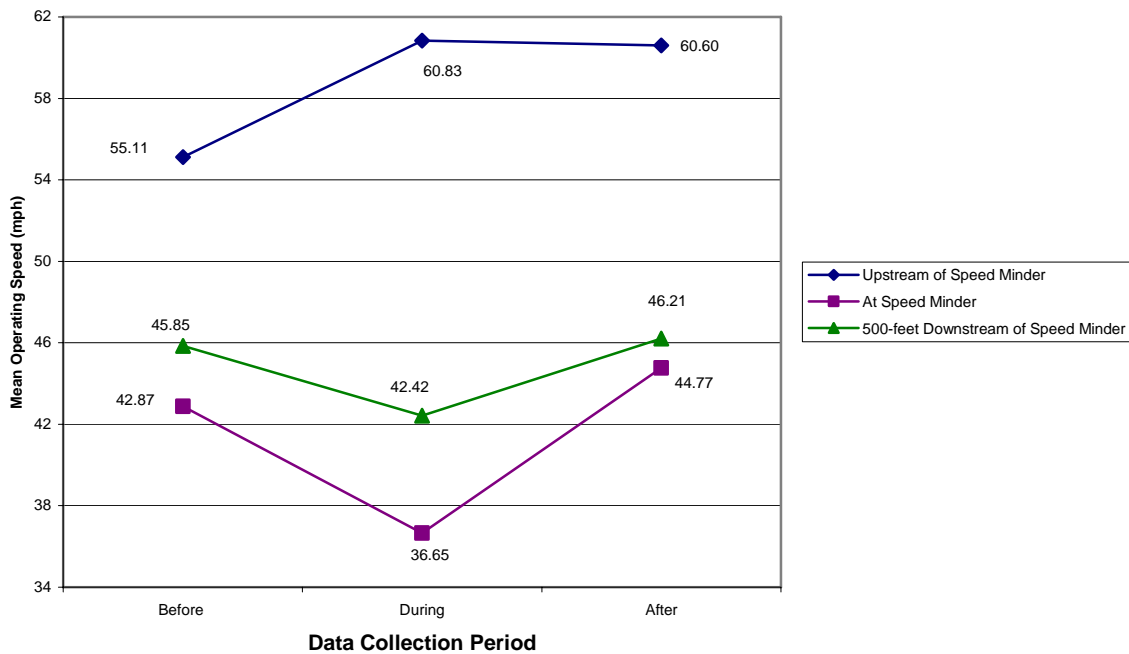
Figure A-3. Speed Profile Plot for State Route 192 (Segments 0210-0220).

The t-tests shown in Table A-6 compare the mean speeds at each sensor location before and during, and during and after, speed minder implementation. The results indicate that the difference in mean speeds at sensor #1 was statistically significant when comparing the before to during periods (higher speeds in during period); however, no statistically significant difference was observed when comparing the during and after periods at the upstream sensor location. This result was not expected and, therefore, the speed differential analysis described in section 5.3 will provide a more accurate representation of the speed minder effect at this particular site.

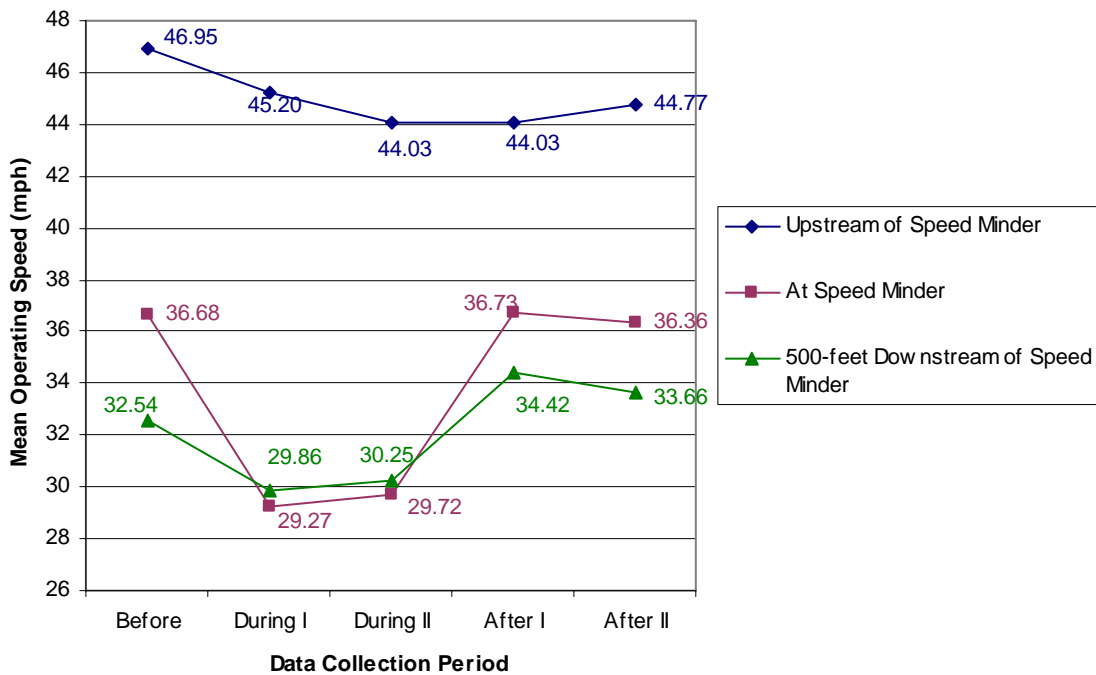
Figure A-4. Speed Profile Plot for State Route 53.

It was expected that the before, during, and after speeds would be nearly equal at sensor #1, which was placed upstream of the speed minder implementation point along the study segment. It was also expected that the speeds at the speed minder location (sensor #2) would be lower than the speeds at the upstream location during the before period because this site is a transition zone where the regulatory speed changes from 45 to 25 mph.

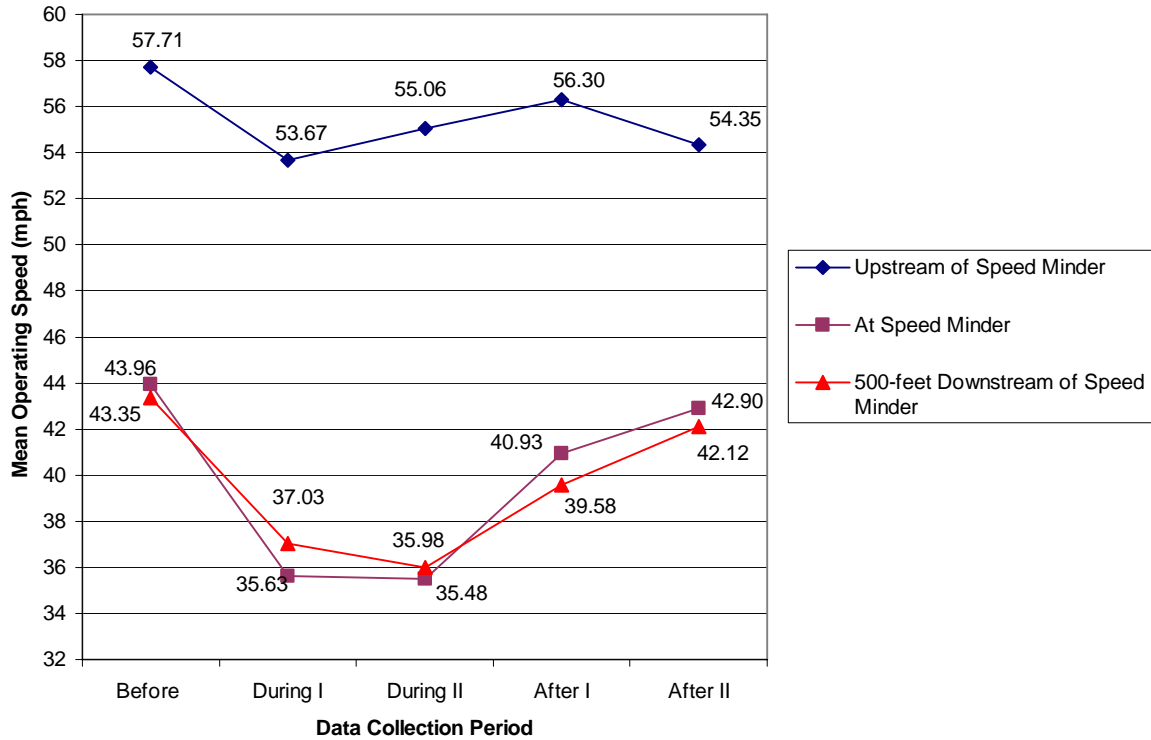
Figure A-5. Speed Profile Plot for State Route 3040.

The t-tests shown in Table A-10 compare the mean speeds at each sensor location during all five data collection time periods. The results indicate that, the difference in mean speeds at sensor #1 were statistically significant when comparing the before to the first during period; however, no statistically significant difference was observed when comparing the two during periods and the first after and second during periods. There was a statistically significant increase in the observed mean speeds between the two after periods. These results were not expected; therefore, the speed reduction analysis described in section 5.3 will provide a more accurate representation of the speed minder effect.

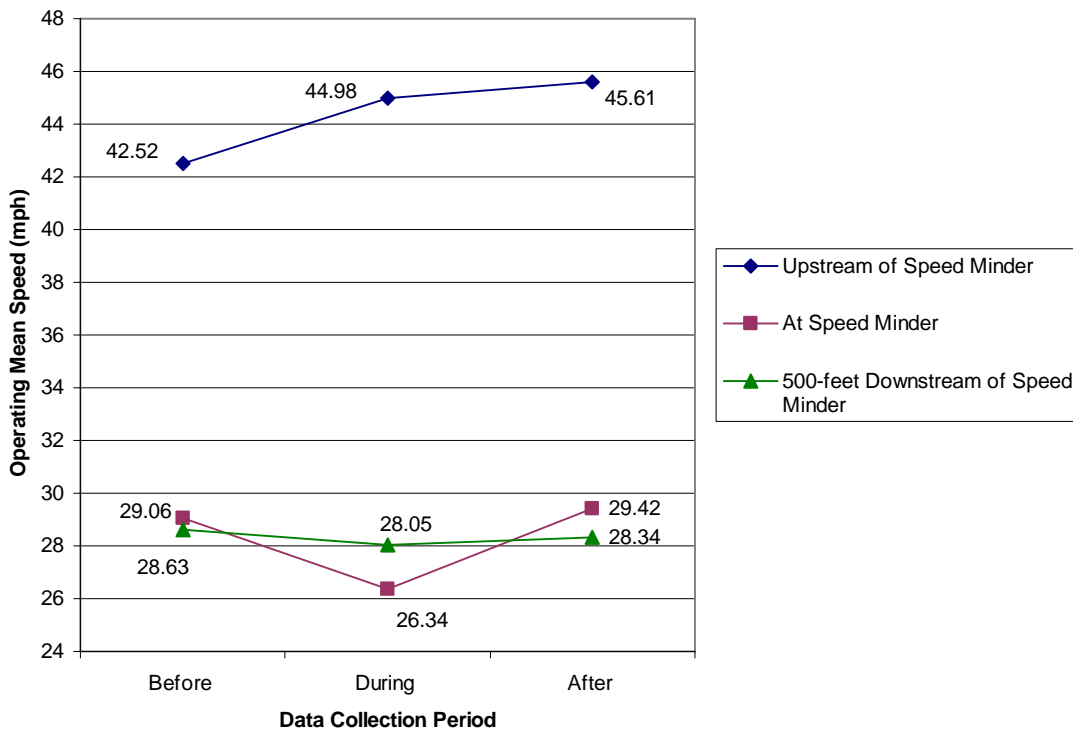
Figure A-6. Speed Profile Plot for State Route 453.

The t-tests shown in Table A-12 compare the mean speeds at each sensor location before and during, and during and after, speed minder implementation. The results indicate that the difference in mean speeds at sensor #1 was statistically significant when comparing the before and during periods, but not different when comparing the during and after periods. This result was not expected and therefore the speed reduction analysis

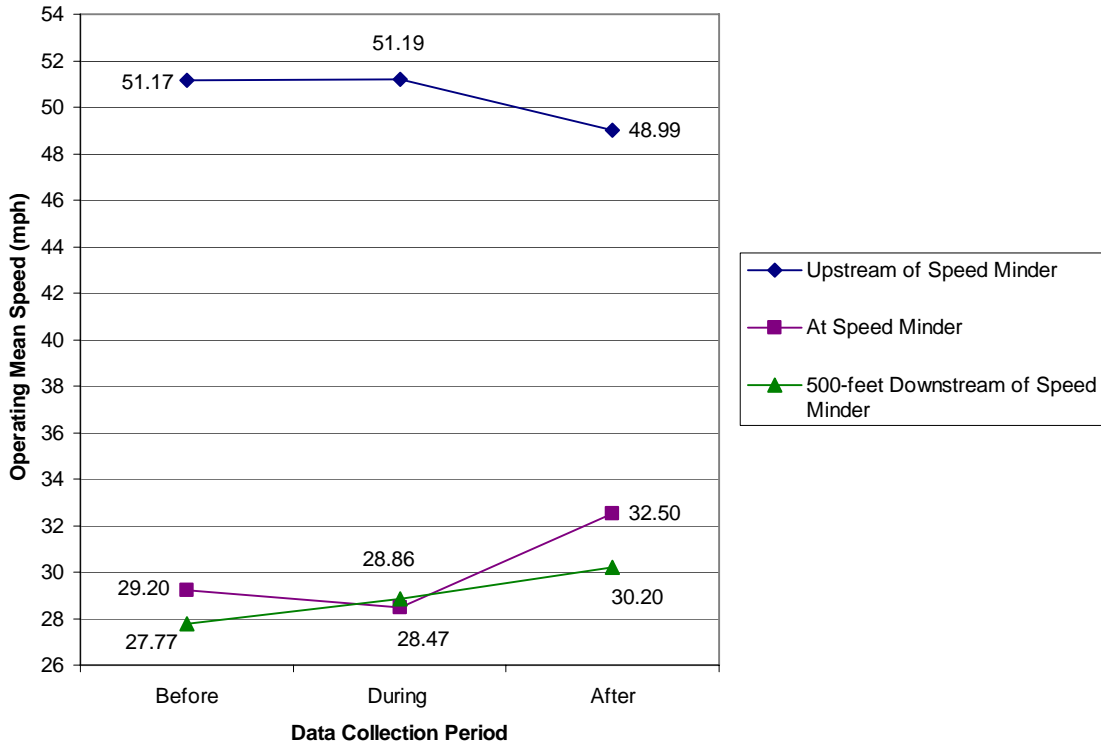
Figure A-7. Speed Profile Plot for State Route 879.

The t-tests shown in Table A-14 compare the mean speeds at each sensor location before and during, and during and after, speed minder implementation. The results indicate that the difference in mean speeds at sensor #1 was not statistically significant when comparing the before and during periods, but were different when comparing the during and after periods. As such, the speed reduction analysis presented in section 5.3 will provide a more accurate representation of the speed minder effect.

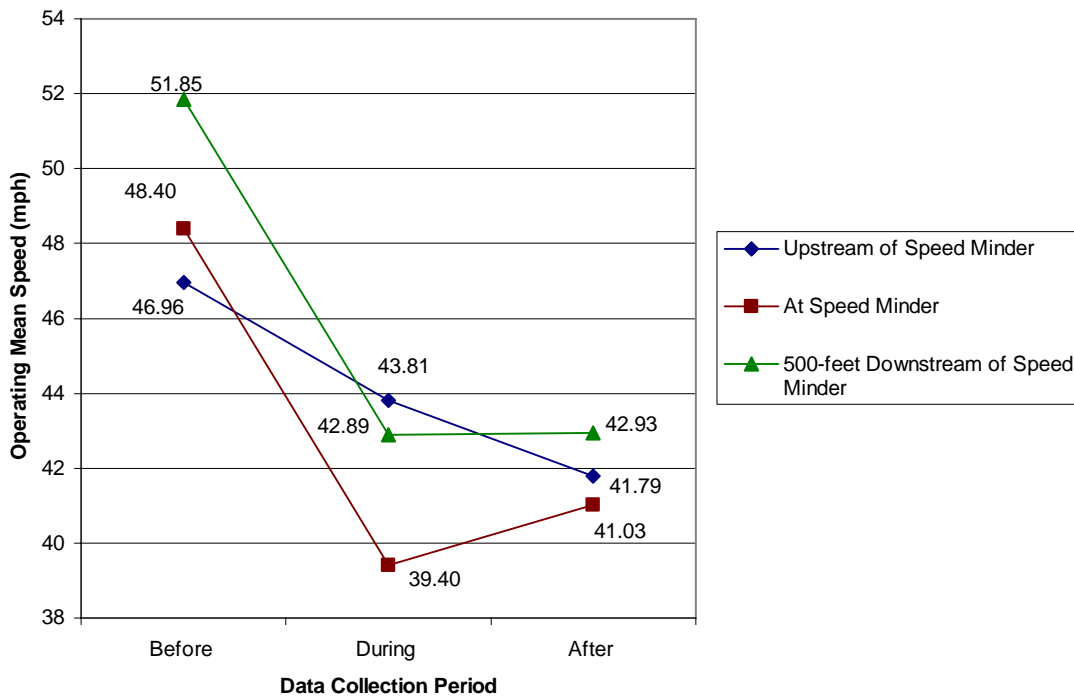
Figure A-8. Speed Profile Plot for State Route 56.

It was expected that the before, during, and after mean speeds would be nearly equal at sensor #1, which was placed upstream of the speed minder implementation point along the study segment. It was also expected that the speeds at the speed minder point (sensor #2) would be equal to the observed mean speeds at the upstream location during the before period because the regulatory speed did not change along this study section. During the time that the speed minder was in place (during period), it was expected that the observed free-flow speeds would decrease when compared to the before period. At the downstream sensor location (#3), it was hypothesized that the observed speeds would be nearly equal to the speeds observed at sensor location #2.

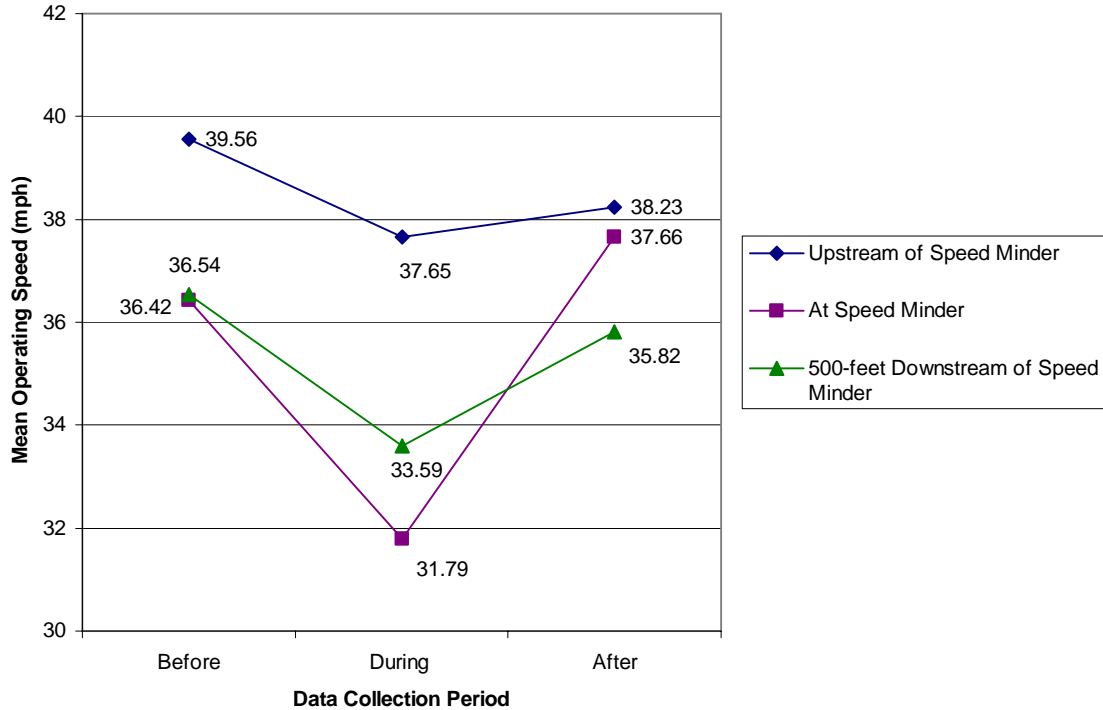
Figure A-12. Speed Profile Plot for State Route 3035.

The t-tests shown in Table A-24 compare the mean speeds at each sensor location before and during, and during and after, speed minder implementation. As expected, the results indicate that the difference in mean speeds at sensor #1 was not statistically significant when comparing any of the successive data collection time periods. At the speed minder location, the mean speeds were lower in the during period than in the before period by approximately 4.6 mph; this result was statistically significant. After the speed minder was removed, the mean speeds increased at sensor #2 by 5.9 mph, to a level that was slightly higher than the speed prior to implementing the speed minder. At the downstream sensor location (#3), the mean speeds decreased by 3.0 mph after the speed minder was implemented, but increased by 2.2 mph after the device was removed. These results are shown graphically in Figure A-12. The statistical tests indicate that the speed minder was effective in reducing the observed mean speed of passenger cars while in place and activated; however, the effect did not remain after the speed minder was removed.

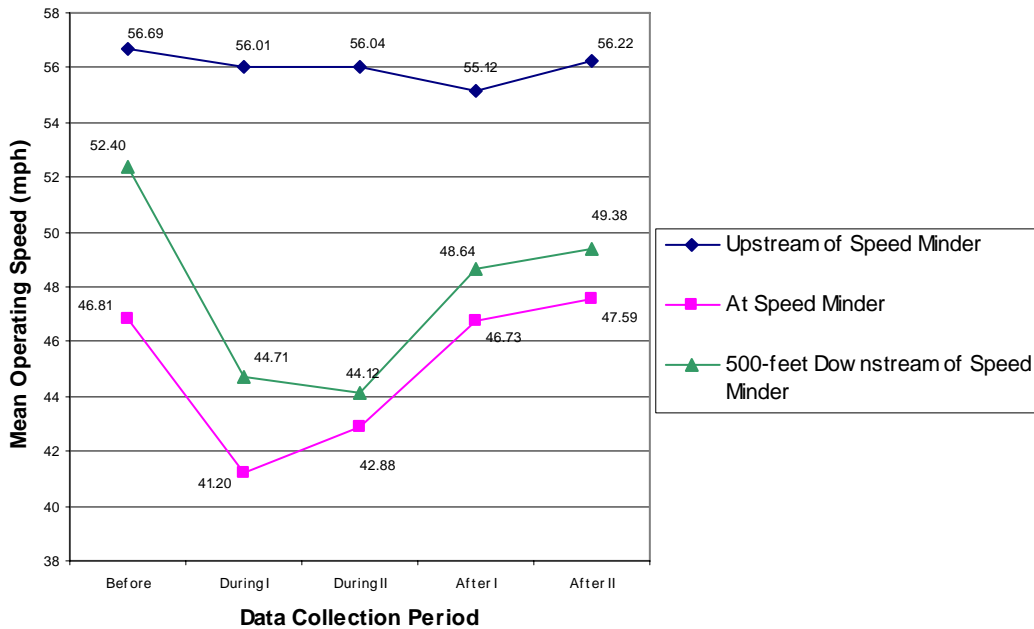
Figure A-13. Speed Profile Plot for State Route 110.

It was expected that the before, during, and after speeds would be nearly equal at sensor #1, which was placed upstream of the speed minder site along the study segment. It was also expected that the speeds at the speed minder location (sensor #2) would be lower than the speeds at the upstream location during the before period because this site is a transition zone where the regulatory speed changes from 55 to 35 mph. During the time that the speed minder was in place (during period), it was expected that the observed free-flow speeds would decrease when compared to the before period. At the downstream

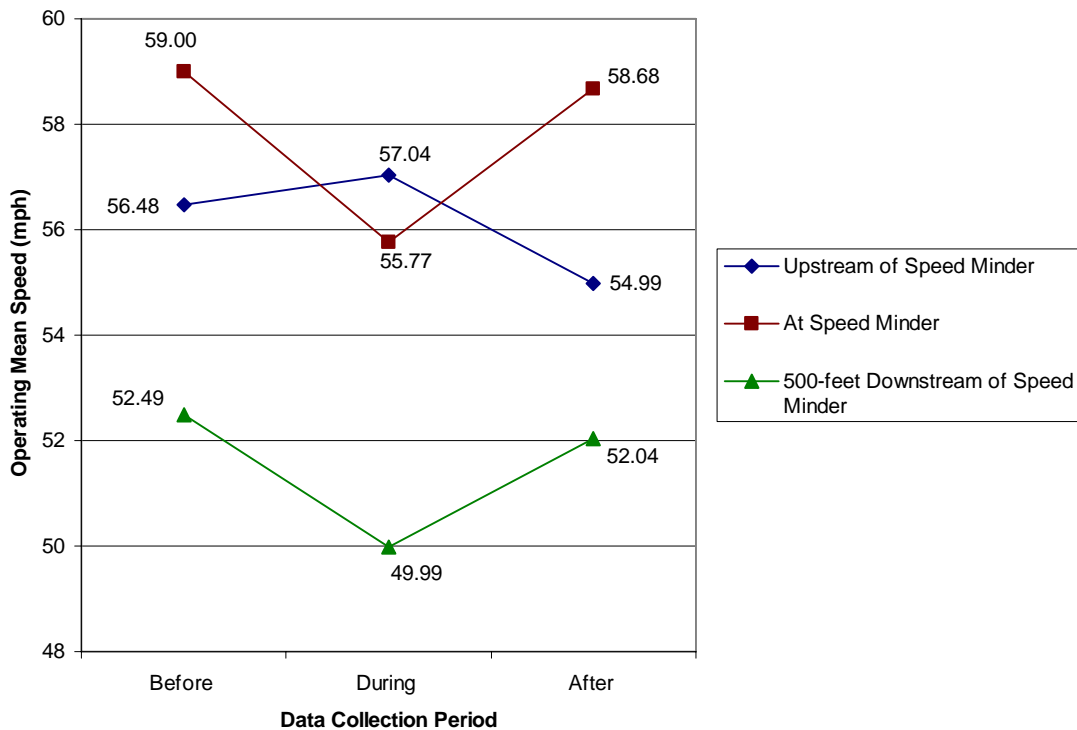
Figure A-14. Speed Profile Plot for State Route 422 (Armstrong County).

The t-tests shown in Table A-28 compare the mean speeds at each sensor location before and during, and during and after, speed minder implementation. The results indicate that, as expected, the difference in mean speeds at sensor #1 was not statistically significant when comparing the before and during periods; however, the mean speeds were approximately 2.0 mph lower in the after period when compared to the during period. At the speed minder location, the mean speeds were lower in the during period than in the before period by approximately 3.2 mph. This result was expected and statistically significant. After the speed minder was removed, the mean speeds increased at sensor #2 by 2.9 mph to a level that was approximately equal to the before data collection period. At the downstream sensor location (#3), the mean speeds decreased by 2.5 mph after the speed minder was implemented. The observed mean speeds then increased by approximately 2.0 mph 1 week after the speed minder was removed. These results are shown graphically in Figure A-14. The results of the statistical testing show that the speed minder was effective in reducing the observed mean operating speeds at this site; however, the speed reductions that resulted from the speed minder being activated did not remain after the device was removed.

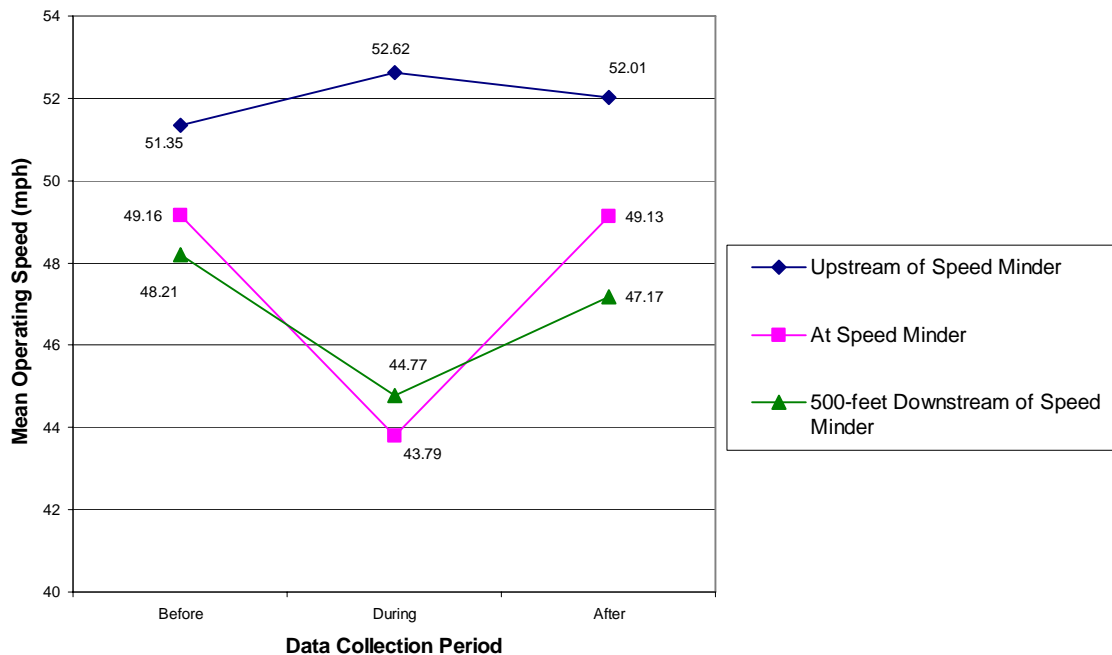
Figure A-15. Speed Profile Plot for State Route 356.

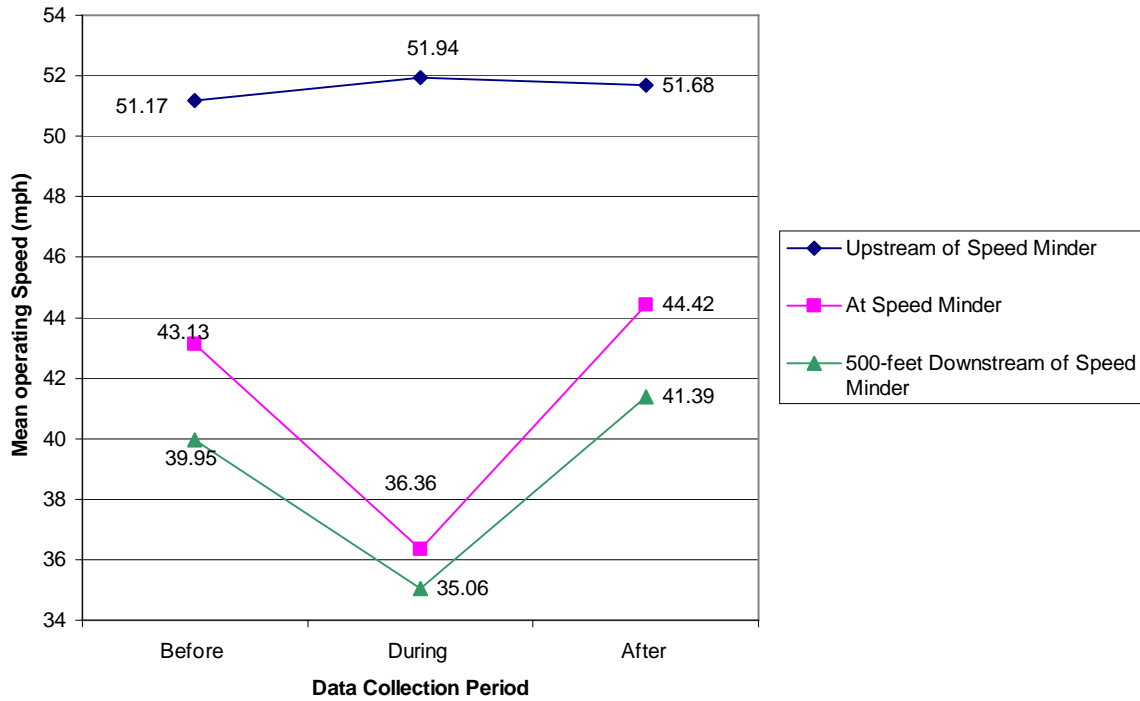
higher than the mean speed prior to implementing the speed minder. At the downstream sensor location (#3), the mean speeds decreased by 4.9 mph after the speed minder was implemented, but increased by 6.3 mph after the device was removed. These results are shown graphically in Figure A-17. The statistical tests indicate that the speed minder was effective in reducing the observed mean speed of passenger cars while in place and activated; however, the effect did not remain after the speed minder was removed.

Figure A-17. Speed Profile Plot for State Route 322.
