DAMAGE ASSESSMENT OF ADJACENT CONCRETE BOX BEAM BRIDGE SYSTEMS

by Clay Naito, Associate Professor, Lehigh University

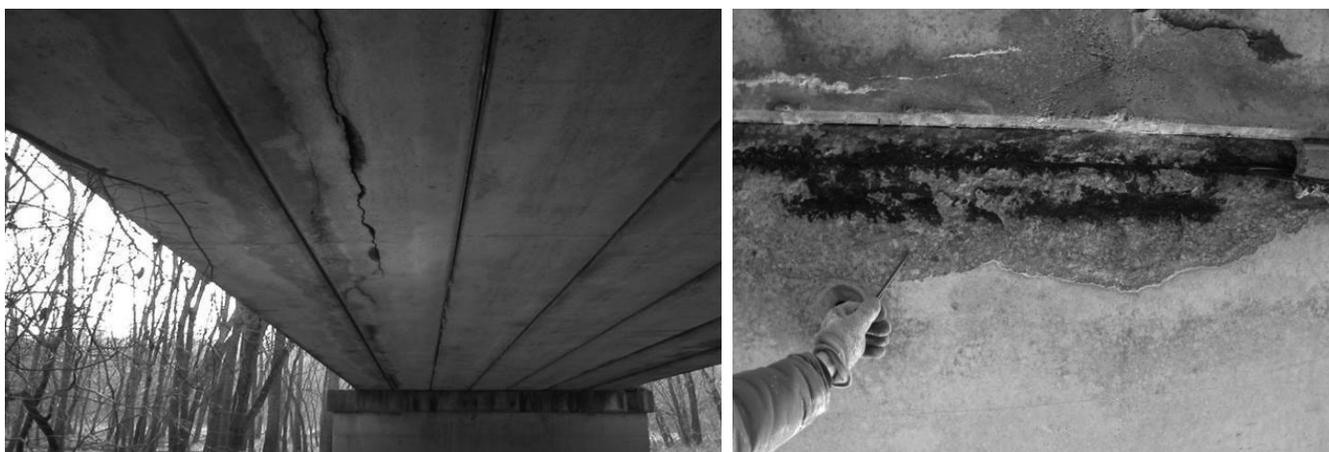
Figure 4: Longitudinal cracking (left) and spalling and delamination (right) induced by corrosion of the steel reinforcement

When reinforcement bars or prestressing strands within the concrete corrode, the size of the reinforcement can increase up to seven times its original diameter. This increase in size places tensile forces on the surrounding concrete, causing it to crack. Cracking typically manifests as longitudinal splitting cracks, localized spalling around the reinforcement, or delamination of a section of the beam. In general, corrosion of one reinforcing bar or strand is associated with longitudinal cracking while corrosion of multiple adjacent reinforcing bars or strands can result in spalling or delamination of the concrete. Figures 3 and 4 illustrate examples of corrosion-induced deterioration.

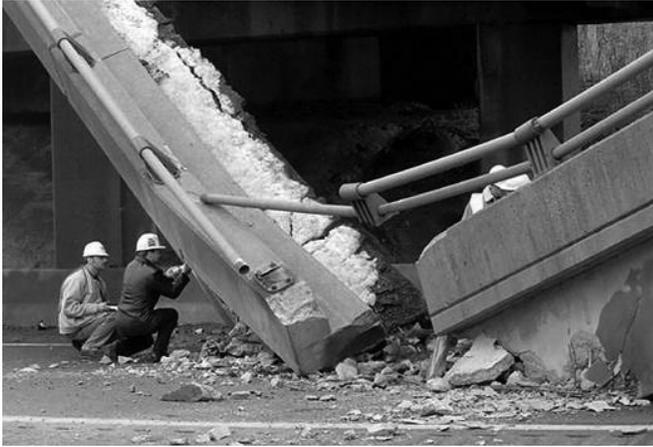
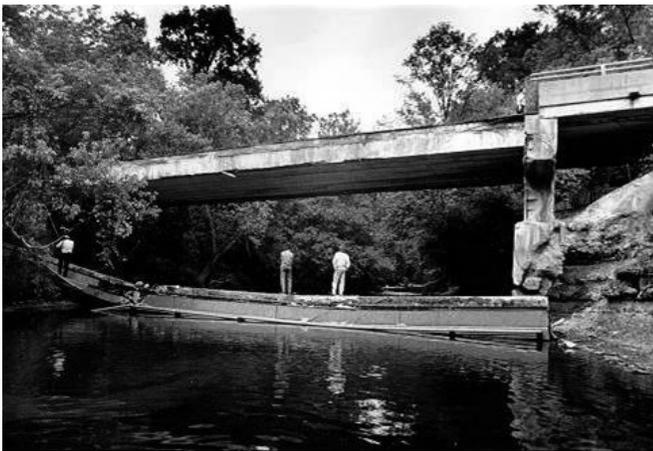
Figure 5: Prestressed bridge beam failures in Pennsylvania and Ohio

The reinforcement plays a vital role in the integrity of the bridge component. Corrosion or damage to the reinforcement can lead to catastrophic failure of the system. The bridge beam failures in Figure 5 show what can happen if strand corrosion and damage are left unchecked.
