## CONDITION OF LOCALLY OWNED BRIDGES

by Ronald J. Ladyka, PE, and Benjamin T. Wigton, EIT

This tech sheet is the first of a three-part series on locally owned bridges. It is intended to serve as a "call to action" for local bridge owners to reevaluate their approach to bridge ownership. Parts 2 and 3 in this series will explain in further detail inspection and maintenance practices for locally owned bridges.

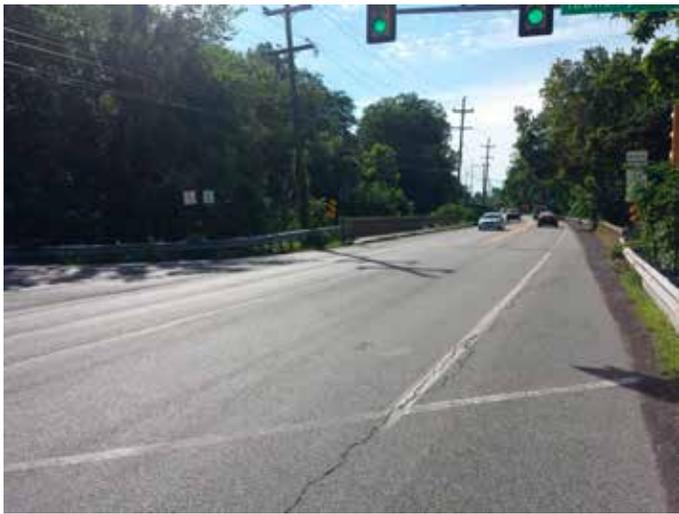
The bridge site near approach load posting sign (at right) is visually obstructed by vegetation growth.

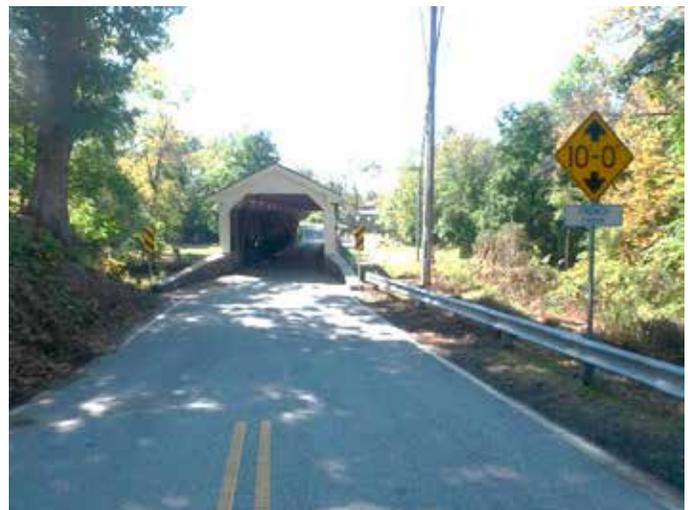
The bridge width here is substandard compared to the approaching roadway. Note the hazardous clearance markers at the bridge.
